Petrochemical company uses online information to keep critical machine running

Gulf Petrochemical Industries Company, Bahrain

by **Ron Bosmans**
Principal Engineer
Bently Nevada Corporation

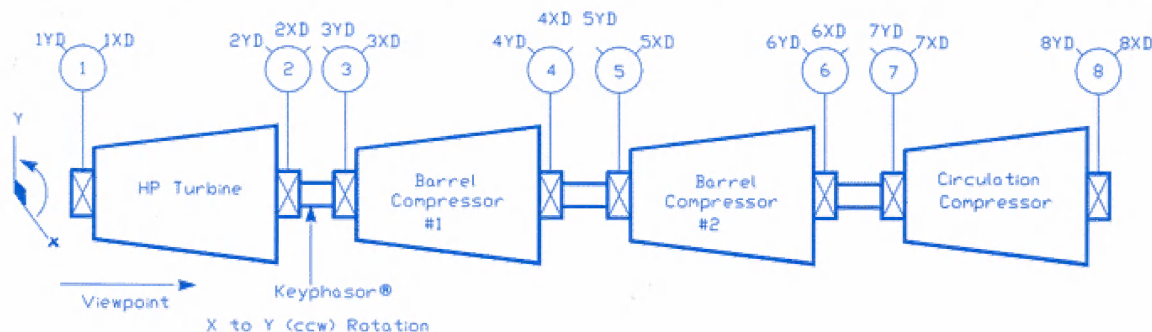
Figure 1
Makeup gas compressor train

tenance Section. The machine train consists of a mechanical drive steam turbine, two barrel compressors, and a circulation compressor. An analysis of this machine train was conducted on December 11, 1994.

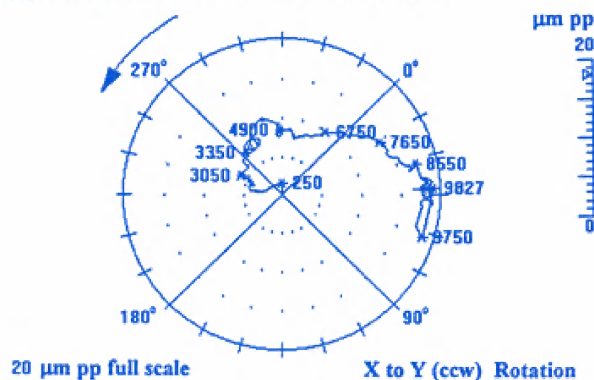
Figure 4
Polar plot of October 1993 shutdown

Three Bently Nevada products contributed to provide actionable information and to assist plant management and maintenance personnel to manage their machinery. The TDM2 System revealed the time history of the changes in the 1X vectors. A second Acceptance Region was defined on 15 December to carefully monitor any further degradation. Violation of the new Acceptance Region would be cause for an immediate shutdown. Speed and the flow rate were reduced to control the level of the increasing 1X vibration. The ADRE® for Windows data from the previous shutdown was instrumental in revealing the location of the second balance resonance.

POINT: DISCHARGE HORIZ /45° Right 1X COMP SR: 2.56/357° (man)
MACHINE: 2nd BARREL
From 25OCT93 13:48:30 To 25OCT93 15:58:54 Shutdown
